Squeaking in Total Hip Replacement: No Cause for Concern

T.M. Ecker; C. Robbins; G. van Flandern; D. Patch; S.D. Steppacher; B. Bierbaum; S.B. Murphy

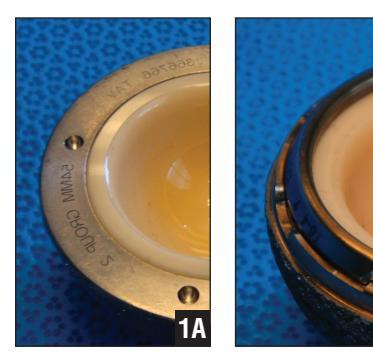
Figure 1: To investigate the influence of the rim design on the incidence of squeaking the reviewed hips were divided into two groups, one with flush (left) and one with recessed mounted ceramic liners (right). Figure 2: Squeaking hip with metal-onmetal impingement. Top left: The recessed liner of the cup (Trident cup) shows notching from the impingement (small arrow) with a corresponding impairment (big arrow) on the neck (Omnifit stem). Top right and bottom left: Same cup with notching from impingement. Bottom right: Beta titanium alloy stem (Accolade stem) with notching signs from metal-on-metal impingement.

evenly with the metal shell (so-called flush-mounted designs; Figure 1). This group included implants manufactured by Wright Medical Technology, Johnson & Johnson, and Biomet. Group 2 represented hip implants where the alumina ceramic acetabular liner was protected by a shroud of titanium at the rim (so-called recessed liners; Figure 1). Group 2 was then divided into 2 groups, with group 2A describing hip implants with a recessed liner mated with a stem made of conventional titanium alloy (TiAl6V4; Omnifit or Securfit stem with Trident Cup; Stryker, Mahwah, New Jersey) and group 2B describing hip implants with a recessed liner combined with stems made out of a beta titanium alloy comprised of 12% molybdenum, 6% zirconium, and 2% iron (Accolade stem with Trident Cup, Stryker).

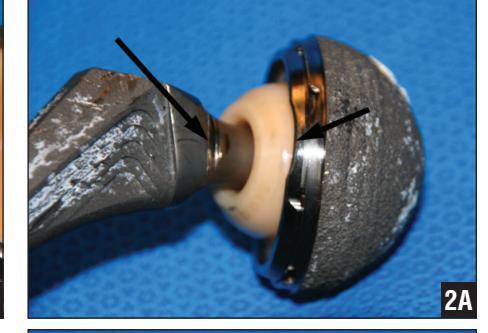
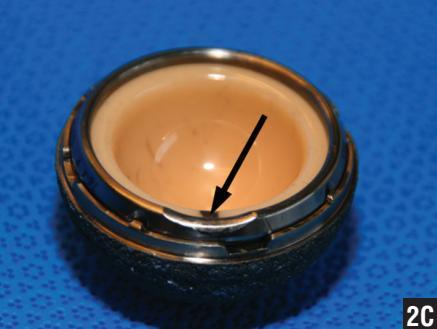
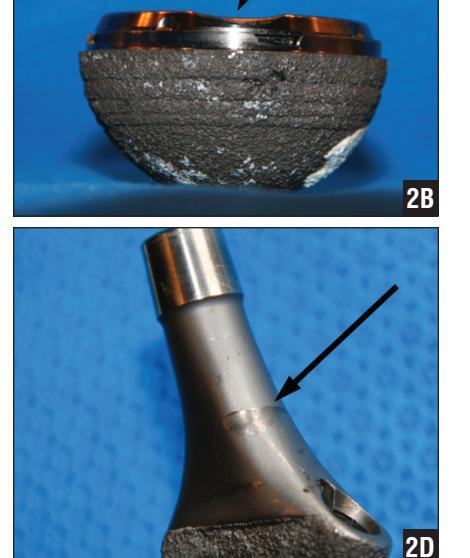
Of the 1275 revision hip arthroplasties, 5 (0.4%) were in patients who had reported squeaking or grinding of alumina ceramic-on-ceramic bearings prior to revision. All 5 hips had a recessed metal-backed ceramic liner and evidence of metallosis.

The current study demonstrates that all revisions of alumina ceramic-on-ceramic hips that generated noise preoperatively were associated with recessed liners with an elevated titanium alloy rim and metal contamination of the bearing. Similarly, the incidence of squeaking in hips with recessed metal liners and an elevated metal rim mated with a stem composed of a beta-titanium alloy was statistically significantly more frequent than with other implant combinations. These findings suggest that the most common primary mechanism for squeaking is not microseparation, stripe wear, or disruption of fluid film lubrication; rather, metal contamination of the bearing occurs primarily, with stripe wear and disruption of fluid film lubrication occurring as a consequence. In addition, metallosis is primarily the consequence of impingement at the extremes of motion, whereas squeaking typically occurs in mid-ranges of motion, such as stair climbing, after the bearing has been compromised. These findings are similar to those of Eichmann¹⁰ who reported squeaking in association with metallosis and neck-rim im-
